Manhole Inspection Summary

Manhole # S35S__008MH

Insp Date: **1/29/08 8:43 AM**

Location Address: **w.clement**

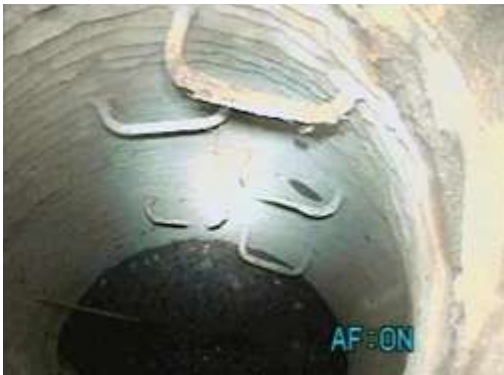
Defect 1

Count: **5** Missing: **2** ☒ **Corroded**

corroded/missing steps

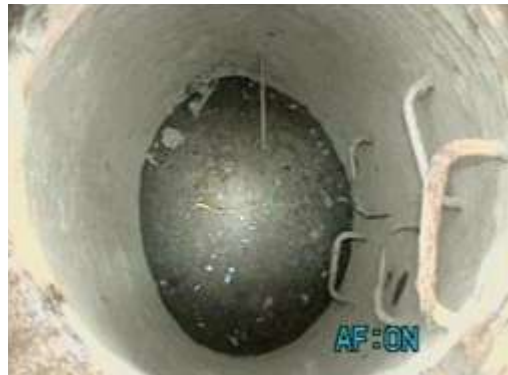
Defect 2

Condition: ☐ Sound ☐ Cracked ☐ Root Intrusion ☐ Deteriorated ☐ Leaks ☒ **Debris**

Channel cond debris

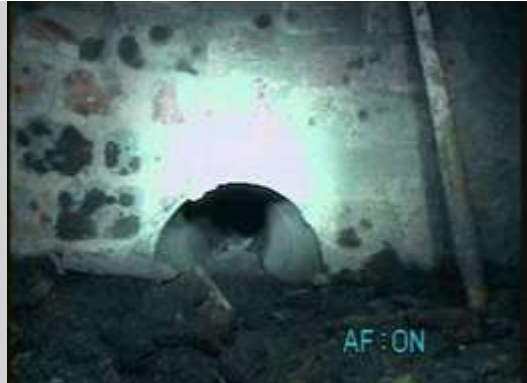
12 O'Clock Outflow

8 in. Circular Gravity Sewer
Pipe Out @ 12 O'Clock

Deposits: ☐ None ☐ Mud ☐ Sludge ☒ **Debris** ☐ Grease

Silt Depth: **2** (in.) Deposits Extent: **Medium**
